April 12, 2002

**SUBJECT: RESPONSE TO CDM COMMENTS  
RAINY CREEK RESTORATION PROJECT**

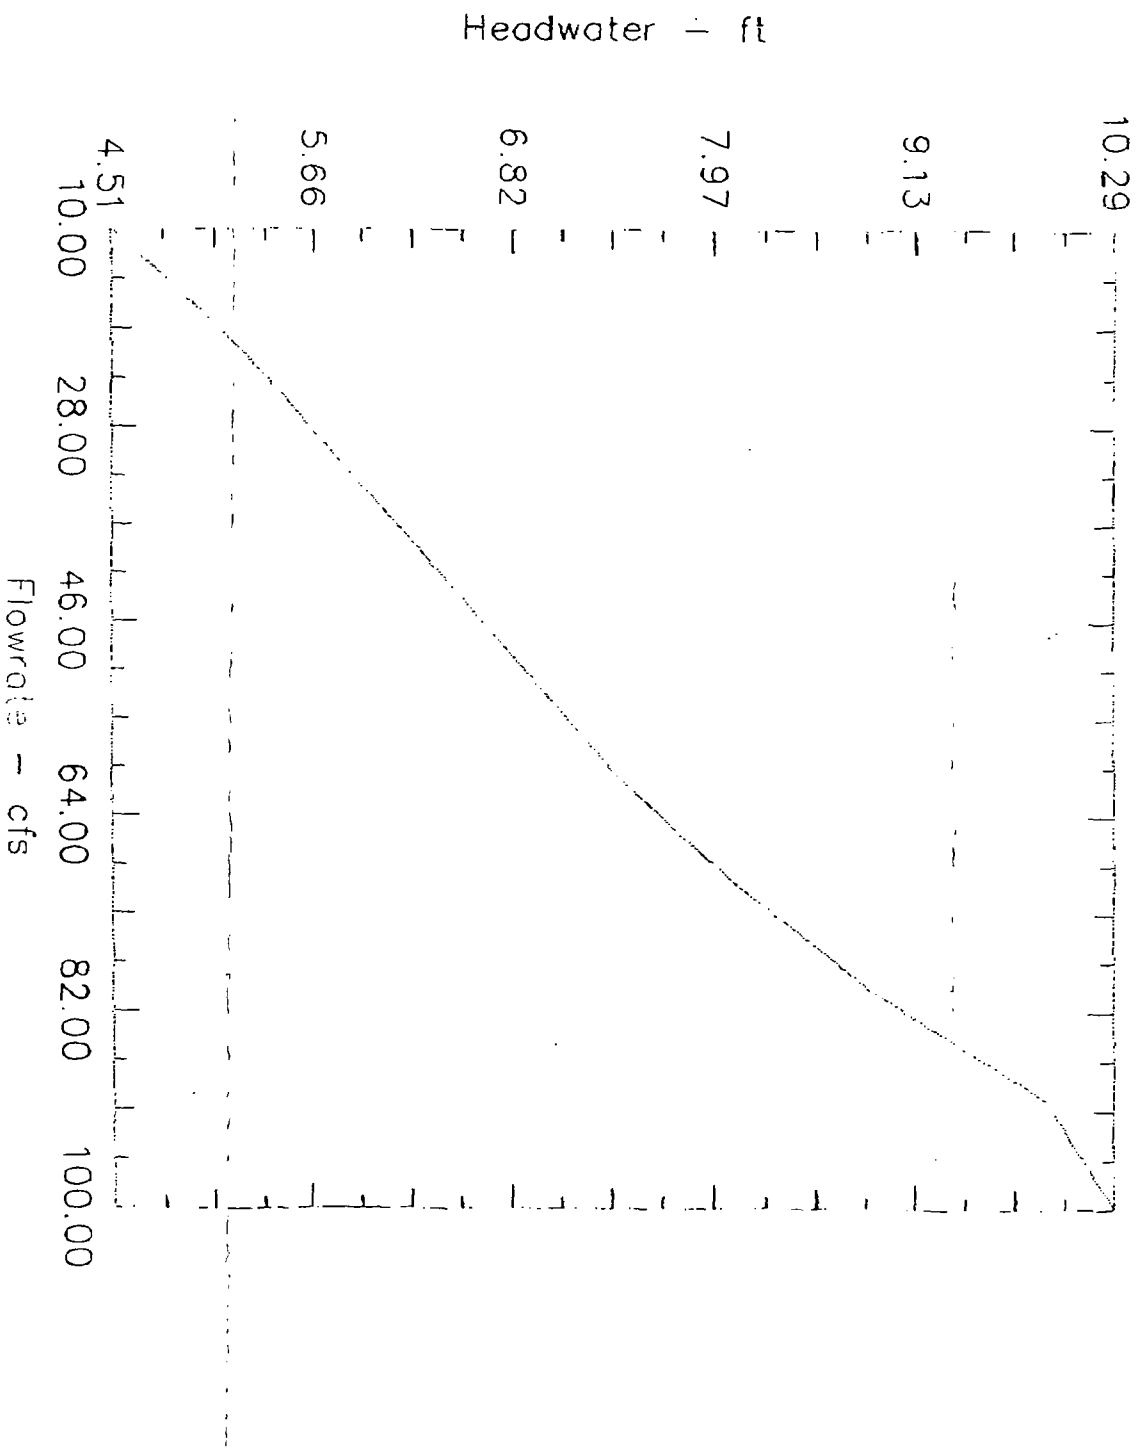
## 42" CMP Performance Curve

DIS- CHARGE Flow cfs	HEAD- WATER ELEV. ft	INLET CONTROL DEPTH ft	OUTLET CONTROL DEPTH ft	FLOW TYPE	NORMAL DEPTH ft	CRITICAL DEPTH ft	OUTLET VEL. fps	OUTLET DEPTH ft	TAILWATER VEL. DEPTH fps ft
10.00	4.51	1.22	0.00	NA	0.62	0.96	8.74	0.62	0.00
3.50									
20.00	5.18	1.89	0.00	NA	0.87	1.37	10.70	0.87	0.00
3.50									
30.00	5.76	2.48	0.00	NA	1.07	1.69	12.02	1.07	0.00
3.50									
40.00	6.32	3.04	0.00	NA	1.25	1.97	13.02	1.25	0.00
3.50									
50.00	6.87	3.58	0.00	NA	1.41	2.21	13.84	1.41	0.00
3.50									
60.00	7.41	4.13	0.00	NA	1.56	2.43	14.53	1.56	0.00
3.50									
70.00	8.07	4.79	0.00	NA	1.70	2.62	15.12	1.70	0.00
3.50									
80.00	8.87	5.59	0.00	NA	1.84	2.79	15.63	1.84	0.00
3.50									
90.00	9.89	6.60	0.00	NA	1.98	2.94	16.07	1.98	0.00
3.50									
100.00	10.29	7.00	0.00	NA	2.11	3.07	16.46	2.11	0.00
3.50
